# Residential Solar Buyer Inspection

## 1428 Redwood Lane

California • Inspection date: August 24, 2026

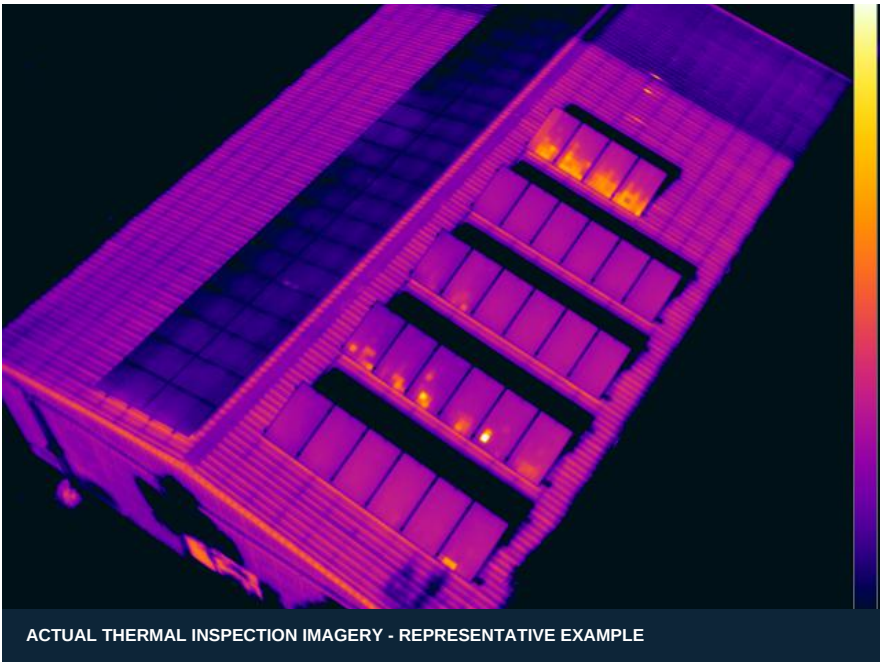
ACTUAL THERMAL INSPECTION IMAGERY - REPRESENTATIVE EXAMPLE

THERMAL STATUS

NORMAL

No material anomalies observed

- Array energized
- Stable irradiance
- Surface comparison made
- No isolated hot cells noted

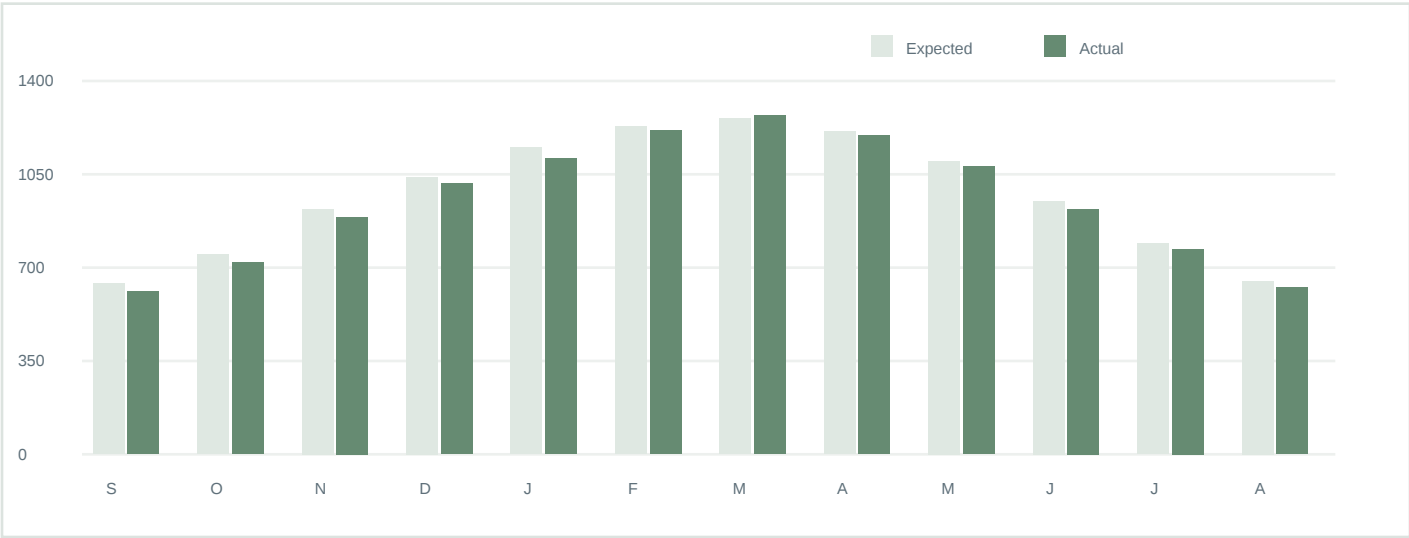
12-MONTH PRODUCTION

**11,420 kWh**  
ACTUAL PRODUCTION

**11,690 kWh**  
REASONABLE EXPECTED

**97.7%**  
ACTUAL VS. EXPECTED

Available history appears generally consistent with reasonable seasonal expectations. A brief monitoring gap in November was documented, but no sustained production outage was visible in the available data.

**MONITORING TRANSFER**  
Buyer should request transfer of monitoring ownership and verify login access before or shortly after closing.
