# Residential Solar Buyer Inspection

## 1428 Redwood Lane

California • Inspection date: August 24, 2026

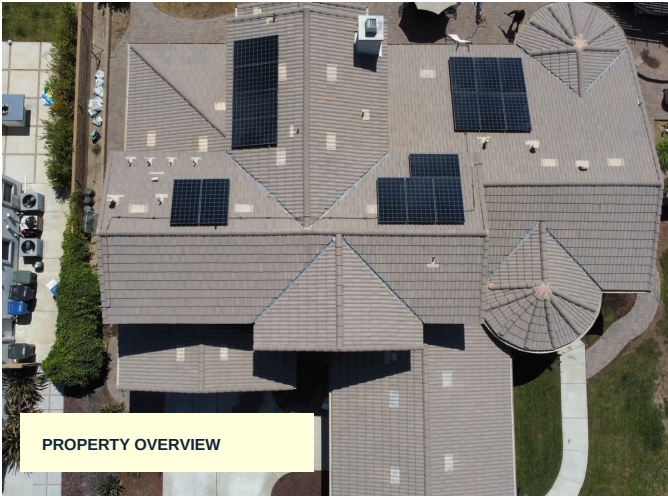
OBSERVED CONFIGURATION

| Array | 19 rooftop PV modules |
| Inverter | String inverter - operating |
| Battery | No battery observed |
